DON'T FORGET ABOUT SHAFTING BENDING IN THE HORIZONTAL PLANE

Dr.Yuriy Batrak, June 2020, Intellectual Maritime Technologies

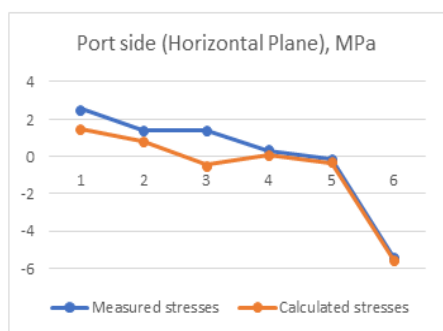
Fig. 1

A ship repair company from Singapore invited us to check shaft alignment of both shaftings on a two screw ship. Several years before, the owner discovered very hard shaft contact with the side shell of intermediate portside and starboard bearings. The bearings had considerable wiping. After they had changed the bearing positions in order to improve the situation, other shafting issues appeared. That's why the ship owner finally decided to check the shaft alignment in the horizontal plane. In this connection IMT with our partner in Singapore conducted a study of shaft alignment parameters using the strain gauges technique. This method was selected because it allowed determining the shaft alignment parameters in both planes simultaneously. The measurements were processed using the ShaftDesigner software (<https://shaftdesigner.software/>) which offers the reverse shaft alignment calculations feature. A good agreement between the calculated and measured bending stress was obtained, Fig 1, 2.
