The Importance of Correct Shaft Alignment Design for Bearing Bush Durability

Dr.Yuriy Batrak, May 2020, Intellectual Maritime Technologies

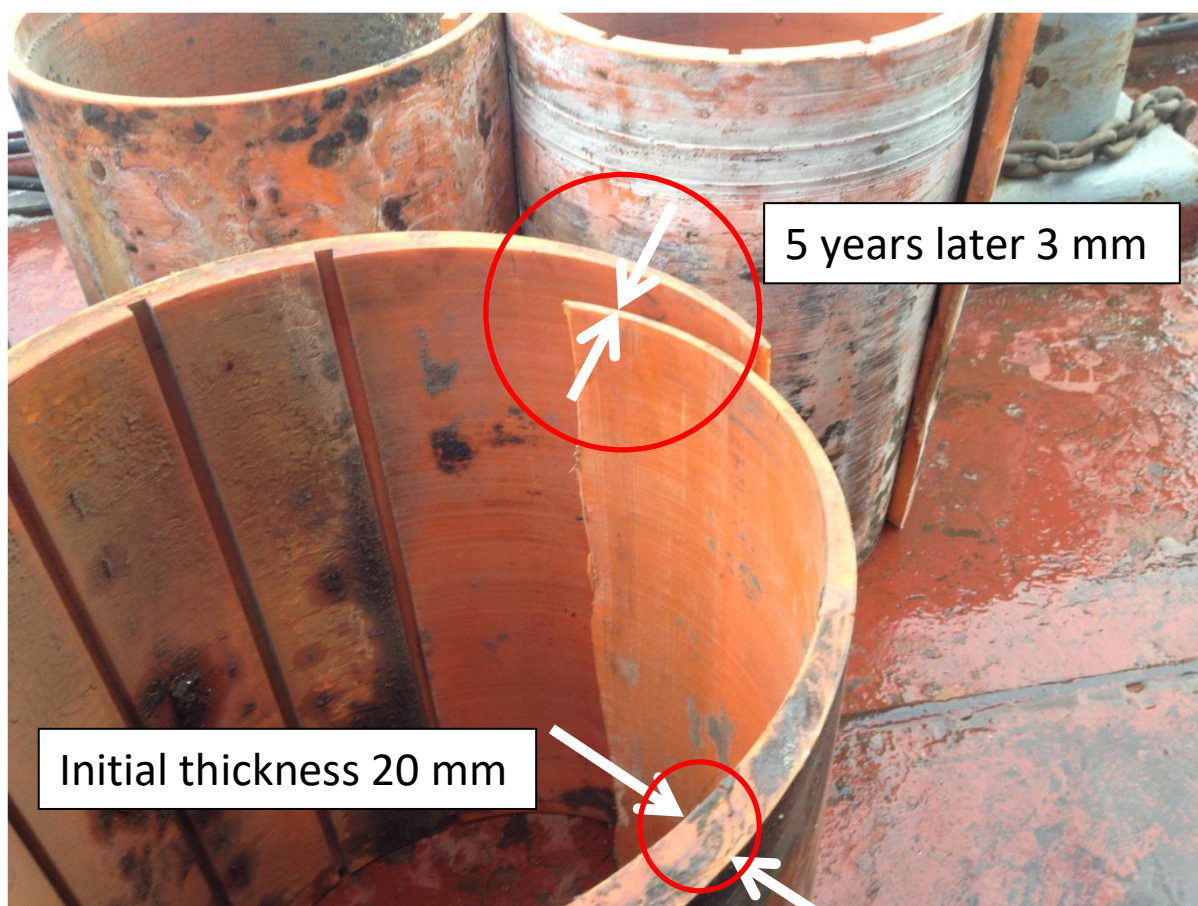
After recalculation of old shaft alignment design bearing overloading was revealed. So there is nothing surprising in quick wear of the bearing. From the very beginning, the bearing worked in the mixed lubrication regime, and then, with increasing wear and radial clearance rise, it completely had switched to boundary lubrication regime. And only the exceptional antifriction properties of the Thordon Compac material allowed the bearing to work so long. It is not excluded that abrasive wear contributed to wear. Scratches on the internal surface of the bush indicate this.

Bearing bushes were replaced and shaft alignment was performed on the base of new shaft alignment design developed with ShaftDesigner software to provide bearings durability.
