Snow Dragon's Bearing Failure Investigation: The Case Study

At 2018 we got a request to investigate the cause of the intermediate bearing failure (wiping of the bearing bush accompanied by a significant temperature increase) that happened at the Chinese icebreaking research vessel Snow Dragon (雪龙, Xue Long in Chinese) on her way home after Arctic region voyage.

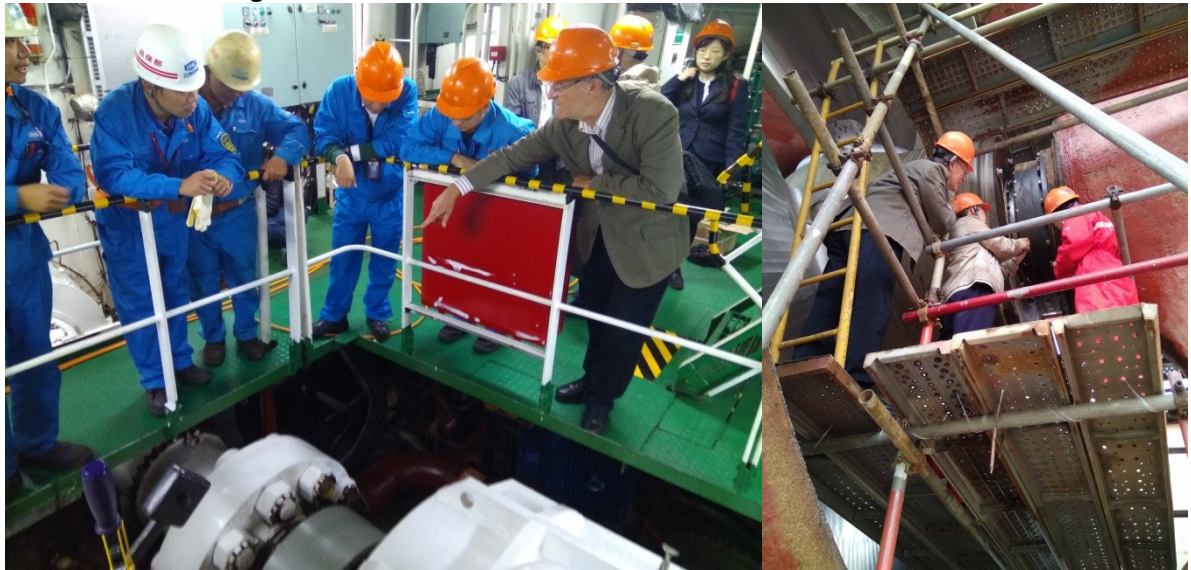
reason; extreme propeller loads in storm conditions; dynamic bearing loads due to ice induced whirling; and the combination of the above reasons. The first two reasons were discarded by the fact that the crew excluded the oil leakage. Besides, the vessel had been operated for 24 years, even in stormy conditions. The only assumption left to check was bearing overloading due to dynamic loads caused by ice induced whirling.

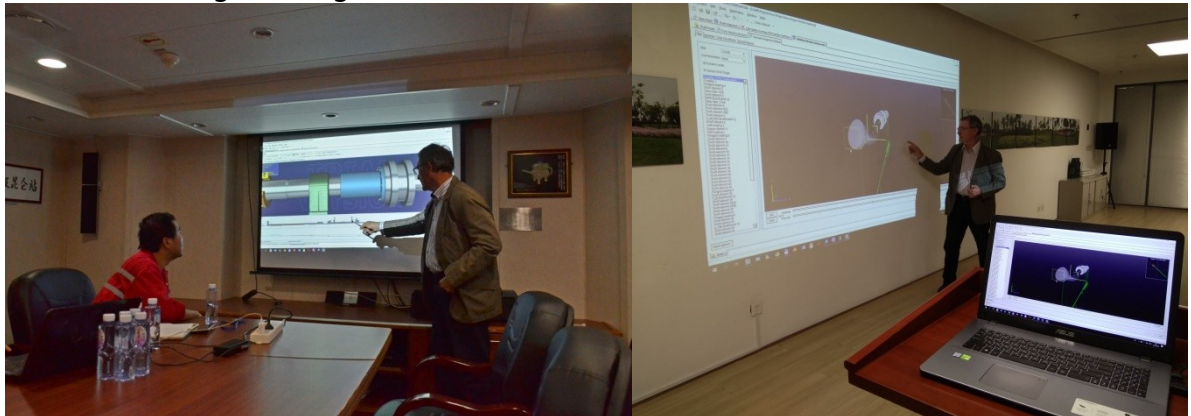
To verify the idea of the bearing failure, our team performed deep comprehensive analysis using the ShaftDesigner software. For this we studied the design and alignment documentation of the shafting, the engine manufacturer measurements performed during the alignment.

The analysis using ShaftDesigner software revealed an unexpected fact that the bearing was 6% overloaded even in normal operating conditions. Studying the available documents concerning shaft alignment, we noticed that according to the old calculations intermediate bearing had only a small margin up to maximum load limit. It should be noted that in this calculation pointwise model for the stern tube bearing was used. When we applied a more realistic extended support model for the stern tube bearing we received the above mentioned 6% overloading.

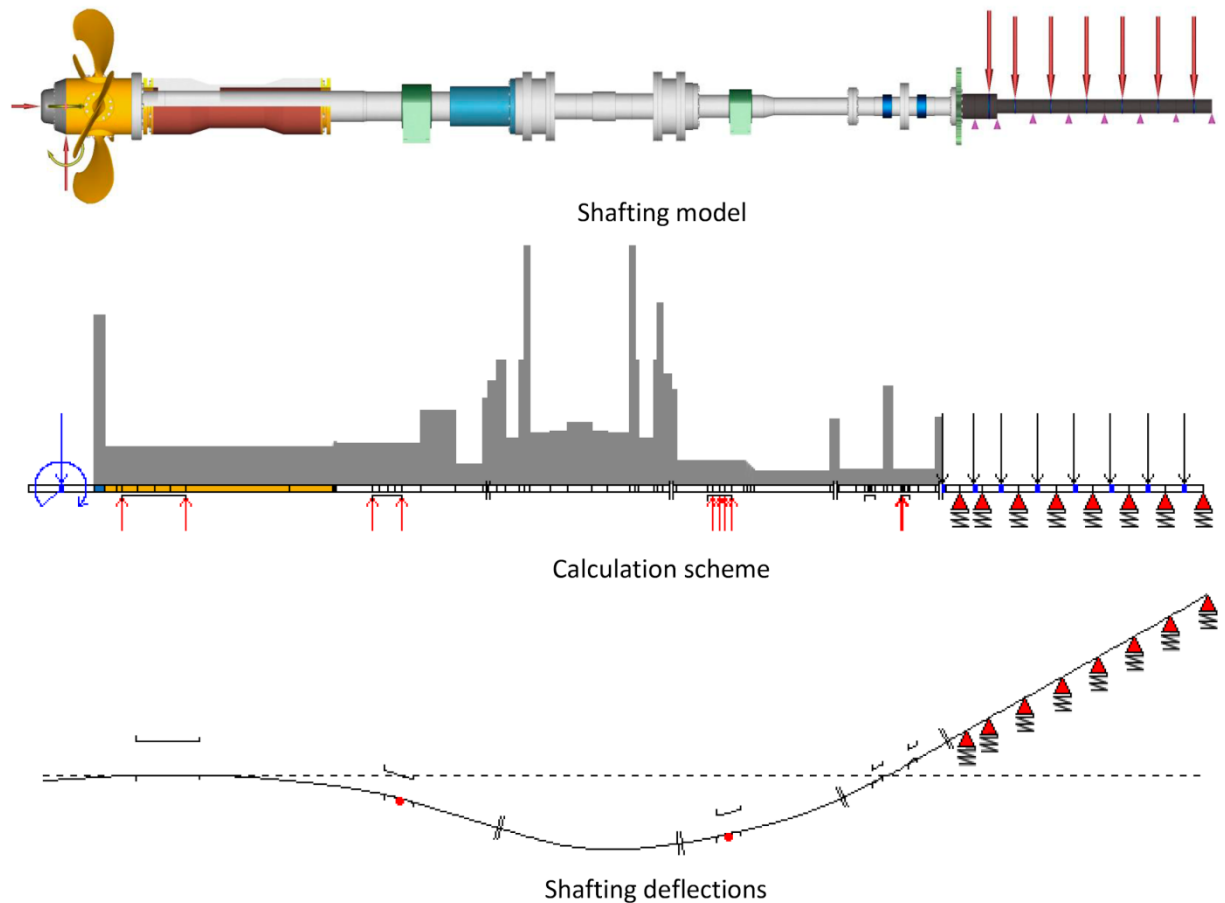
The specific feature of the Xue Long shafting is single stern tube bearing design, that makes the aftmost intermediate bearing more vulnerable to external loads coming from the propeller. Currently Classification Societies develop special requirements for shaft alignment calculations of the vessels with such type of shafting.

Since the load on the bearing exceeds the maximum limit even under normal operating conditions, it is likely that the ice loads on the propeller that occur during ice milling caused a significant dynamic overload of the bearing. Dynamic bearing overload led to the destruction of the white metal liner surface and caused the deterioration of the lubrication conditions. Further developments were obvious.
