## DOUBLE BOTTOM DEFLECTIONS INDUCED BY SOLAR HEAT IN THE DRY DOCK AND AFLOAT

Dr. Yuriy Batrak,  
Mykola Lavrov

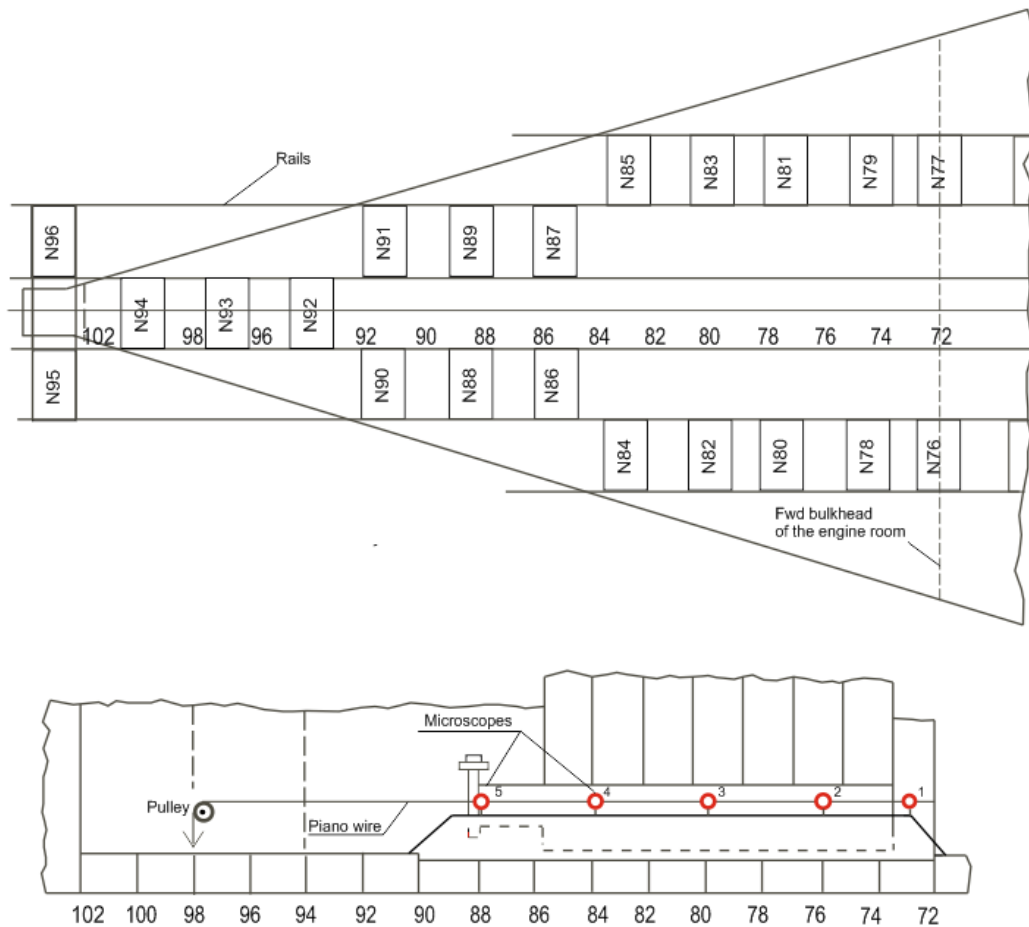
Fig. 1 Arrangement of the ship carrier bogies and measurement equipment

The pistons of the carrier bogies located forward from the engine room were blocked by lock nuts and used as ordinary supports, while the aft hull part was supported by hydraulic jacks with specially set pressures. To exclude the effect of the factors not related to the thermal deflections, the hydraulic jacks pressures were reset twice.

During measurements No.1 the ship hull was supported by ship carrier bogies equipped with hydraulic jacks, Fig. 1.

The double bottom deflections in the vertical plane were measured using MPB-2 type measuring microscopes having the accuracy of  $\pm 0,01$  mm and a piano wire of 0,3 mm diameter (see Fig. 1). The piano wire was tensioned over the engine foundation top plate on the SB side. One end of the wire was fixed on the engine room forward bulkhead; the movable end was attached to the web frame by means of the pulley, in the immediate vicinity of the aft peak bulkhead. The weight hanged on the movable piano wire end ensured constant tension of the wire. Magnetic brackets with measuring microscopes were installed at five positions. The length of the engine room is 23,4 m, the length of the piano wire is 20,8 m.

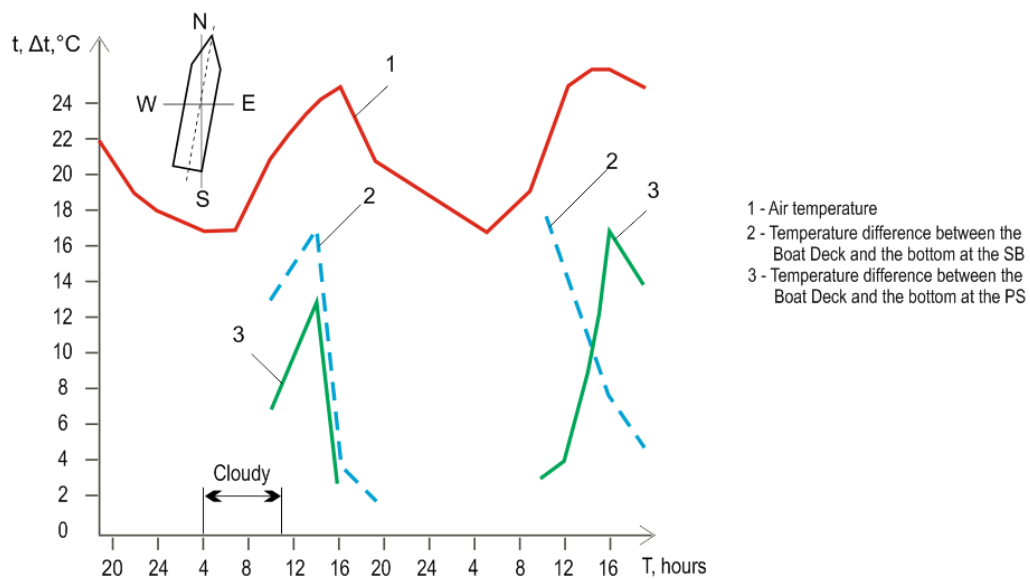
The air temperature and the temperature difference between the boat deck and the bottom for the portside (PS) and the starboard (SB) are shown in Fig. 2. The accuracy of temperature measurements is  $\pm 1$  °C. The maximum difference of the deck and bottom structures temperature is about 18°C.

Fig. 2 Change of the air temperature and the temperature difference between the Boat Deck and the bottom for the PS and the SB for two days.

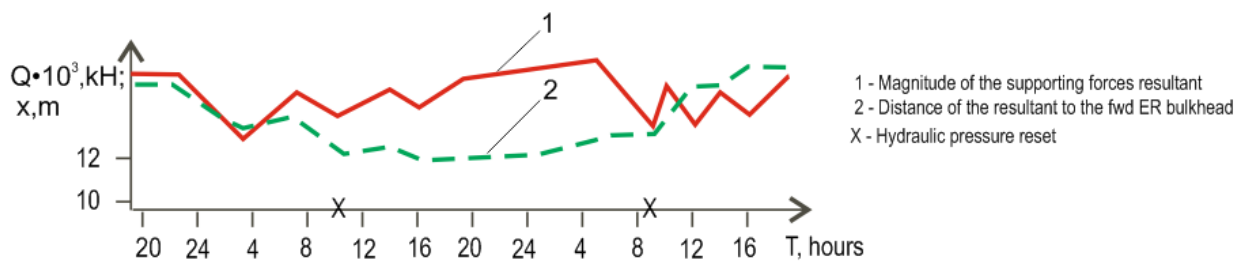
The carrier bogies prevented general hull girder temperature deflections and as a result, the pressure in carrier bogies hydraulic systems and correspondent forces have been changed over time. The supporting forces resultant magnitude and its distance to ER forward bulkhead are depicted in Fig.3. To evaluate the measured deflections FEM model of the engine room double bottom structure in the beam approach was created. External loads which have been applied in the FEM model to the double bottom girders were calculated using the pressure in hydraulic jacks in each specified moment.

Fig. 3 Parameters of the Supporting forces resultant

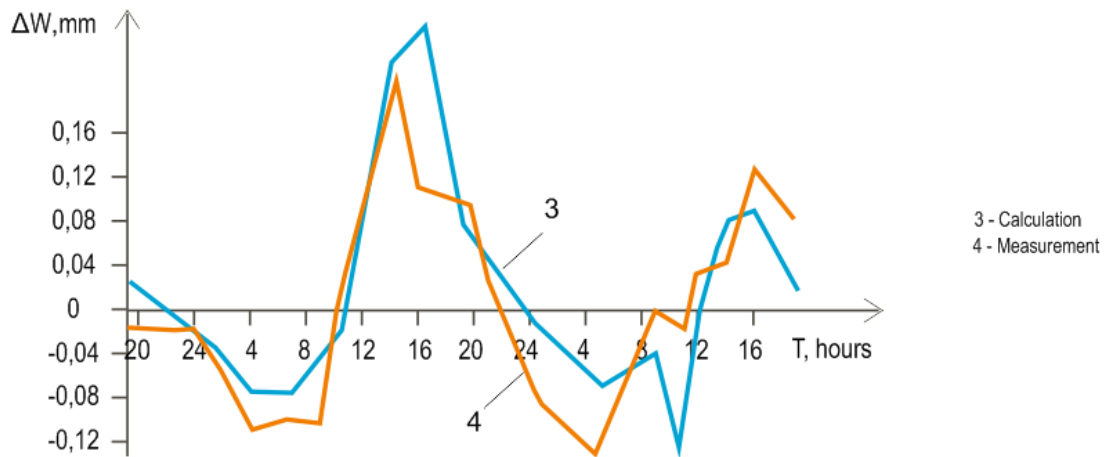
Comparison of the calculated and measured double bottom deflections (Fig. 4) shows satisfactory agreement. Maximum peak-to-peak deflection at point #4 is 0,36 mm. The obtained result makes evident the fact that engine room double bottom deflections in a dry dock occur mainly due to the change of the supporting structure reactions caused by the hull girder general thermal deformation. Thus it is impossible to avoid not controlled machinery misalignment when the ship is in a dry dock.

Fig. 4 Deflection in the middle of the engine room

2. For the ship in a dry dock condition, the engine room local double bottom deflections occur continuously and mainly due to the changes of the support structure reactions caused by general hull girder thermal deformations.

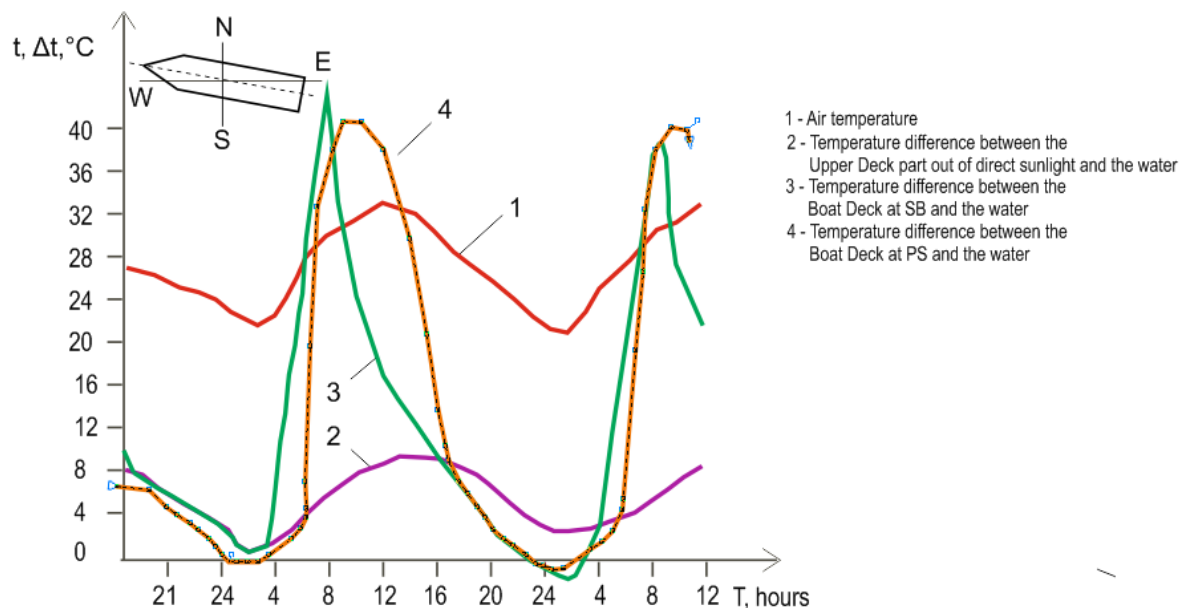
The temperature change curves are shown in the Fig.5. The maximum difference of the deck and bottom structures temperature was 41,0°C. The outboard water temperature changed from 21,5 °C in the night time to 23,0 °C in the day time. The temperature of the hull remained almost constant, around 27,0°C. Only the Boat Deck parts of 4 m wide were exposed to sun heat.

Fig. 5 Air temperature and the temperature difference between the hull structures and the water

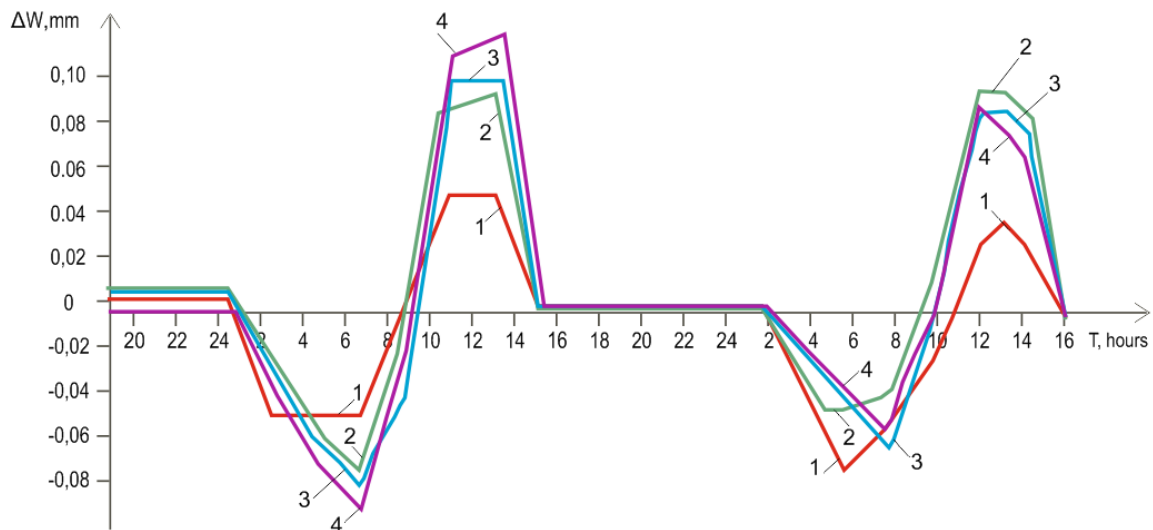
The double bottom deflections were measured using measuring microscopes a piano wire stretched between fore and aft bulkheads of the engine room. The engine room length equal to the deflections measuring area is 24,2 m. Measurements results are shown in Fig. 5.

Fig. 5 double bottom deflections within two days (microscopes Nos. 1-4)
